**STS-109 (BI111)
FLIGHT READINESS REVIEW**

February 14, 2002

Solid Rocket Booster

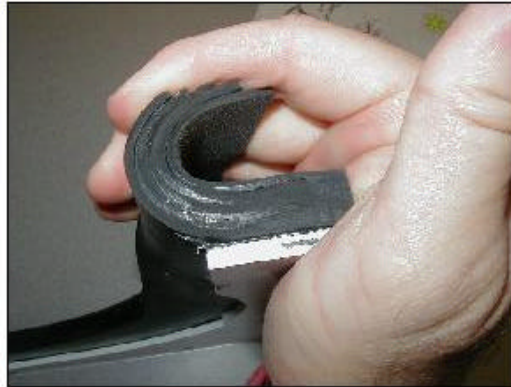
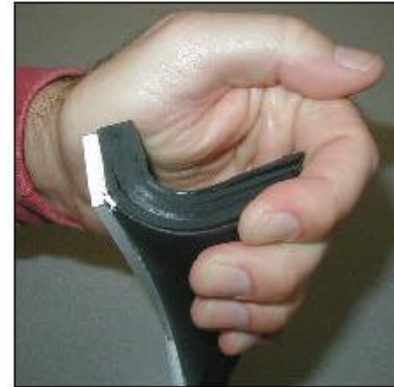
Inspection of SRB EPDM Covers

- Stock sweep performed on in-stock and flown STS-108 covers
 - Visually inspected all covers
 - Hand applied fold back bond test performed on uninstalled covers
 - Materials testing performed
 - Bond strength
 - One additional in-stock cover failed bondline screen
 - Low bond strength evident over full cover bond
 - Corrosion
 - Maximum depth = 0.001 inches
- All STS-109/BI111 covers inspected in place
 - One additional cover failed inspection
 - Removed and replaced
 - Localized repairable debond

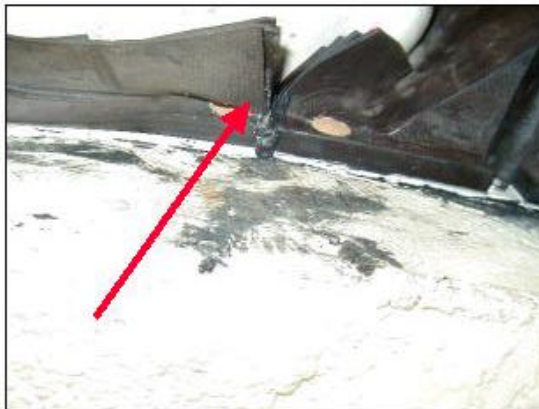
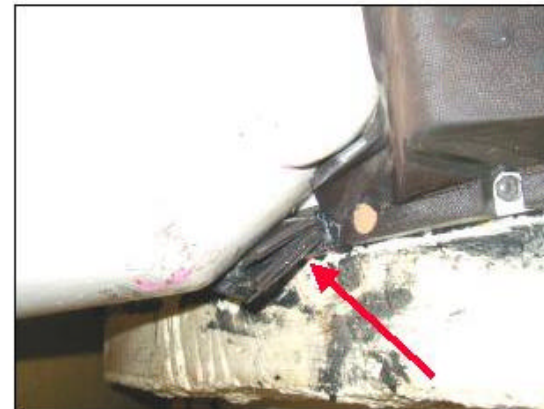
Installed SRB EPDM Cover - RH Upper Strut

- STS-109/BI111 EPDM RH upper strut cover adhesive failed with evidence of corrosion at adhesive bondline
 - Discovered during EPDM strut cover installation in VAB
 - Cover removed and replaced

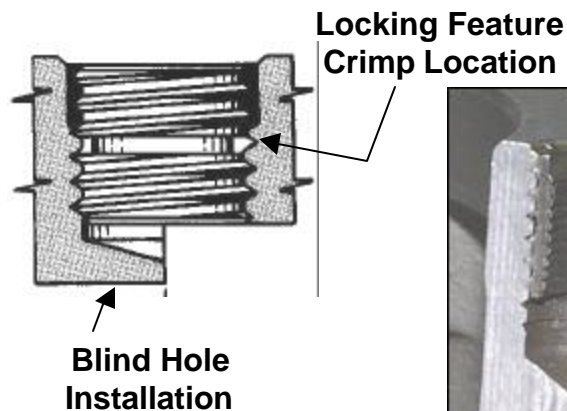
Keensert (6 places)

- Installation torque values (280-300 in.lbs.) could overstress housing threads
 - Keenserts could pull out of aluminum housing

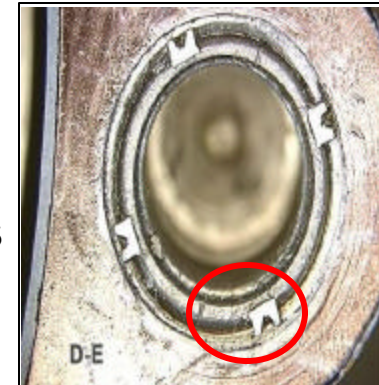
**Keensert Locking
Keys (4 places)**

- SRB pumps refurbished by vendor following every flight
 - Includes visual inspection of threaded Keenserts
 - Occasional Keensert replacement required
 - Replacement results in decreased shear area due to reclocking of locking keys
 - No SRB STS-109 pumps contain replaced Keenserts
 - ATP includes multiple functional checks of suspect joint
 - Proof pressure = 4875 psi (1.5x rated operating pressure)
 - Extensive run time (~8 hrs) with multiple leak checks
 - No indications of pump failure due to housing thread shear
 - Potential incident of stripped threads documented (1999)
 - No evidence of external leakage or performance degradation
- Conservative analysis results in positive margin of safety

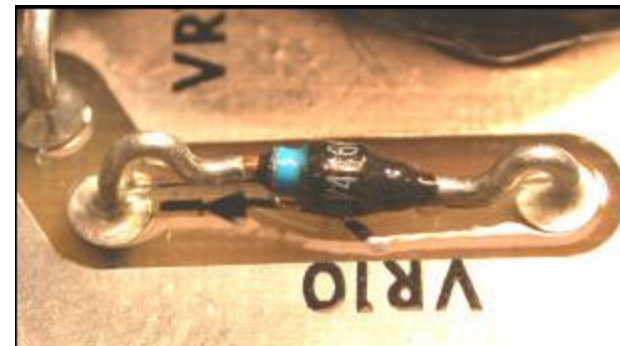
Failed Diode

- Integrated Electronics Assembly (IEA) S/N 025 failed APU BITE test during final acceptance functional test at vendor
 - APU controller Fuel Shutoff Valve (FSV) command alternating between 28 VDC and 0 VDC with BITE frequency applied
- Isolated fault to open Zener diode on APU Controller (APUC) module S/N 158

- Failure repeated in IEA and at card level
- X-ray and visual confirm crack in glass body of diode
- Seven previous cracked Zener diode failures of this part type
 - Four failures prior to 1982
 - One detected during module-level testing, three by inspection
 - Three failures from 1982 through 1989
 - Detected by module-level testing
- Diode failure causes identified in previous investigations
 - Stresses in diode from lead bending/installation angle
 - Lack of diode sleeving
 - Urethane conformal coating negating strain relief of diode
 - Printed Wiring Board (PWB) to diode lead and glass body tied together
 - Urethane coefficient of expansion much greater than diode materials
 - Diode body style/package design

- Corrective action planned
 - Rebaseline functionality of APUC diodes (as available)
 - Improve IEA level testing

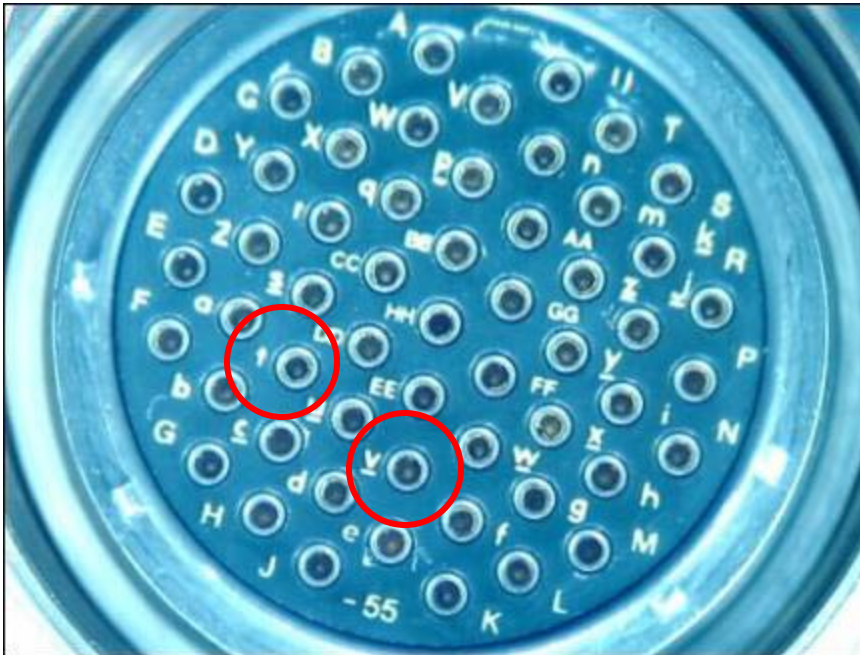
Initial Failed Cable Connector

- Upper Strut Cable Failed Pre-installation Continuity Test in VAB
 - Contact fingers out of position
- Inspection of additional cables found second upper strut cable with same condition

- Initial failed cable
 - NAJ6C22-55SC Connector, Lot Date Code (LDC) 9530
 - One flight only

- LDC identification for STS-109 cables
- LDC determination for like-cables of entire inventory
- Inspection of additional cables
- Review of industry Alerts for cable type, LDC, manufacturer, similar problem, etc.
- Materials and processing evaluation of failed cable(s)

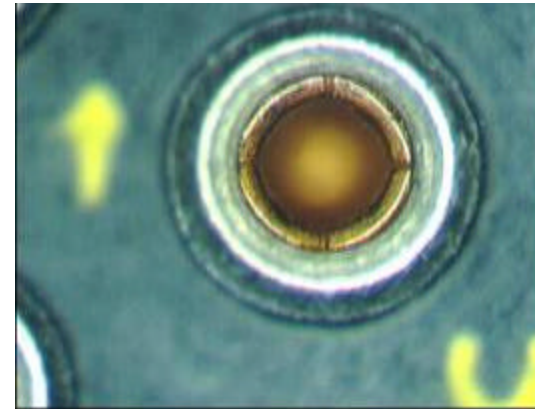
“t” Socket: Acceptable

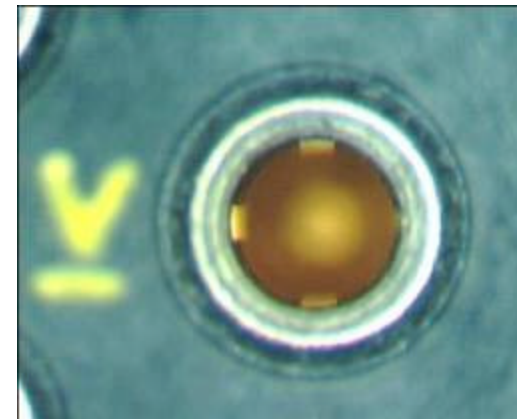
“v” Socket: Unacceptable
